**Information about “Silver Amalgam” Fillings, Our Protocol for Removing Them, and Basics Regarding Their Replacement**  
*by Robert P. McBride, D.D.S., M.A.G.D.*

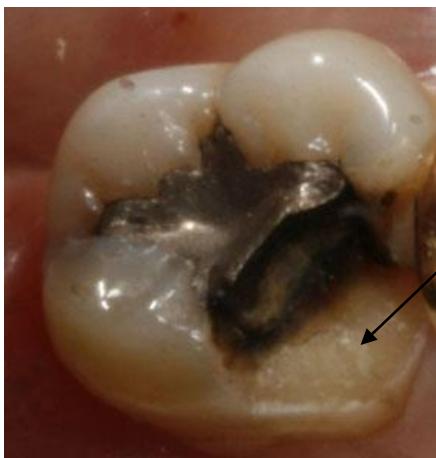
Following is a typical history of incidents that occur during the lifetime of a tooth. First the tooth has a cavity (decay) which traumatizes the nerve (pulp) as bacteria enter it even with a moderate sized decay. Then the decay is drilled out along with some healthy tooth structure to provide undercuts so that the filling won't fall out, as mercury amalgam fillings have absolutely no adhesive qualities – they actually just sit in the tooth. And then they expand and contract at a different rate than the tooth, which cracks from internal expansion that eventually causes tooth structure to break away as seen with this tooth.

1/4<sup>th</sup> of tooth missing – fortunately at the gum level in this case. Many break off below the gum level and/or through the nerve area requiring gum surgery, root canal treatment or extraction.

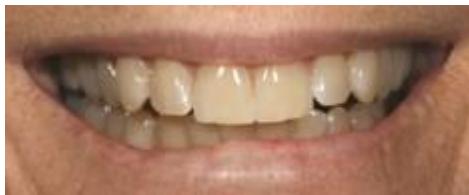
*Treatment done in 1954*

*These images depict cast gold restorative treatment done in 1954 by my patient's previous dentist. He has required no further treatment of his teeth since then and unlike most people his age, will never experience a root canal treatment.*
